Machynys Hotel

Geotechnical and geoenvironmental desk study

Reference: 278688-MMH-ARP-RP-001

P01 | 4 October 2024

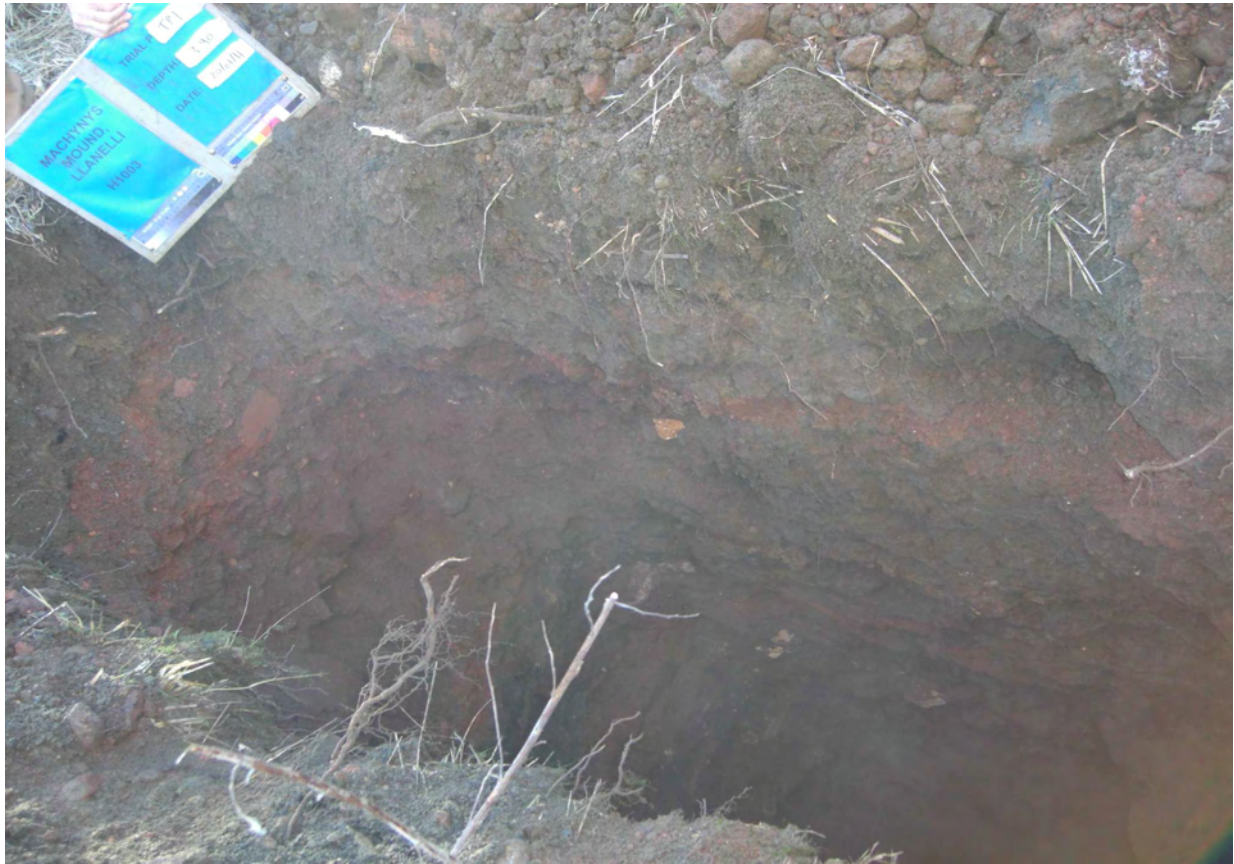
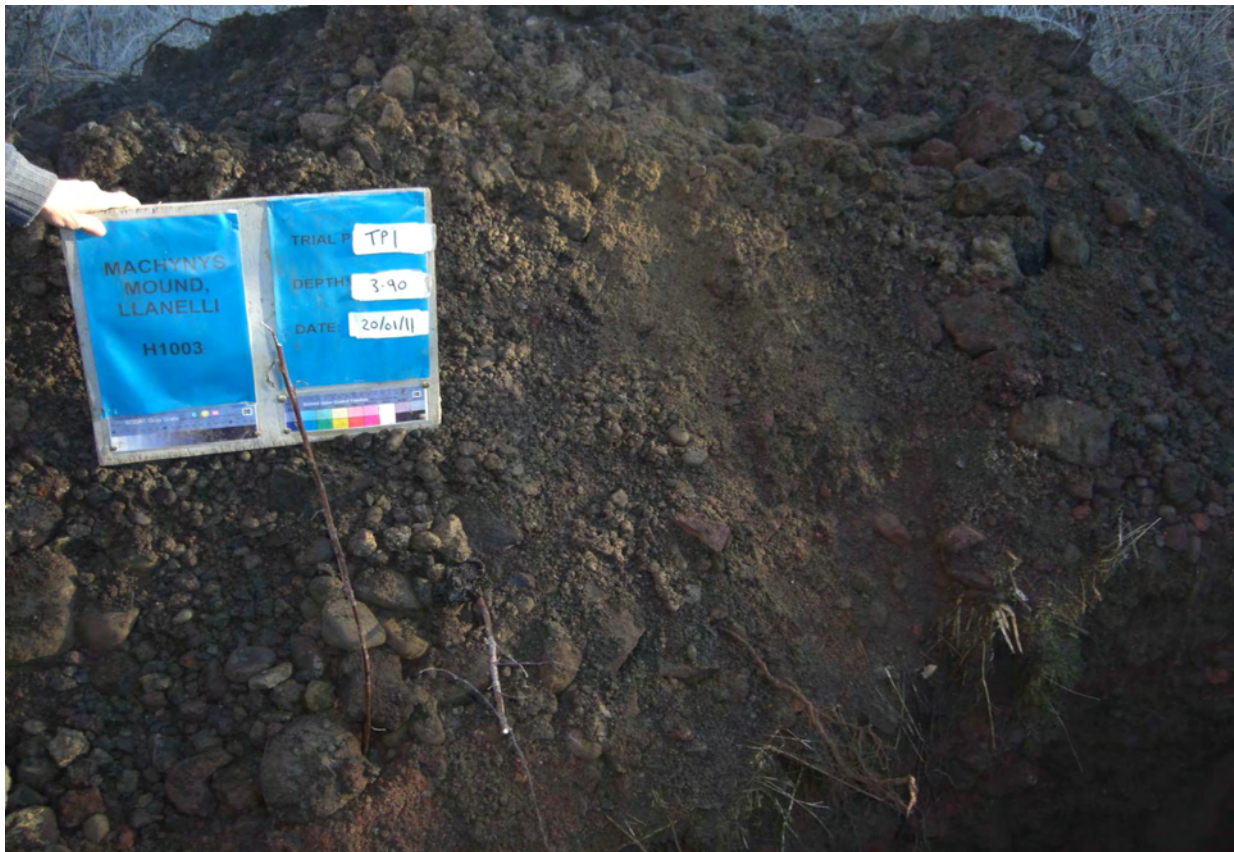
Trial Pit 1

Notes:	Project Machynys Mound, Machynys Project No. H1003-11 Carried out for Carmarthenshire County Council	Figure E2
--------	---	----------------------------

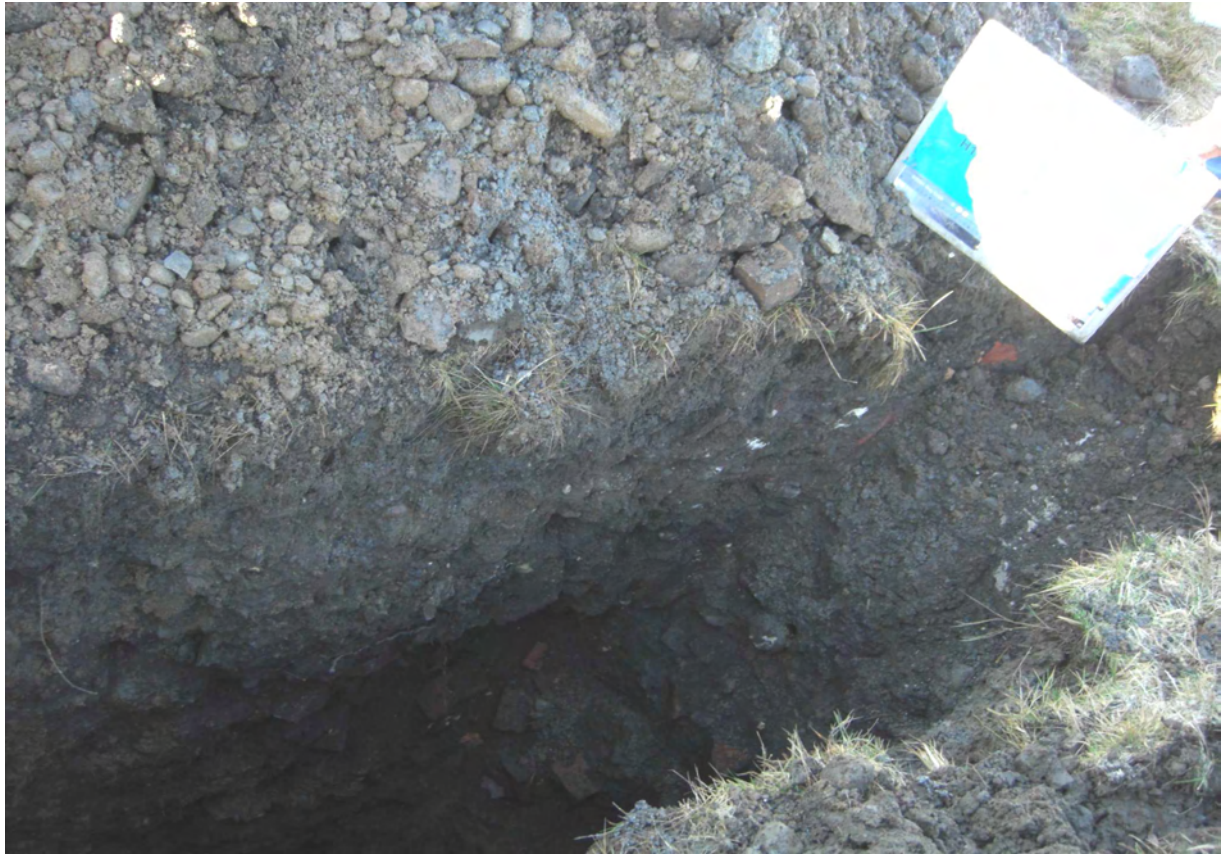
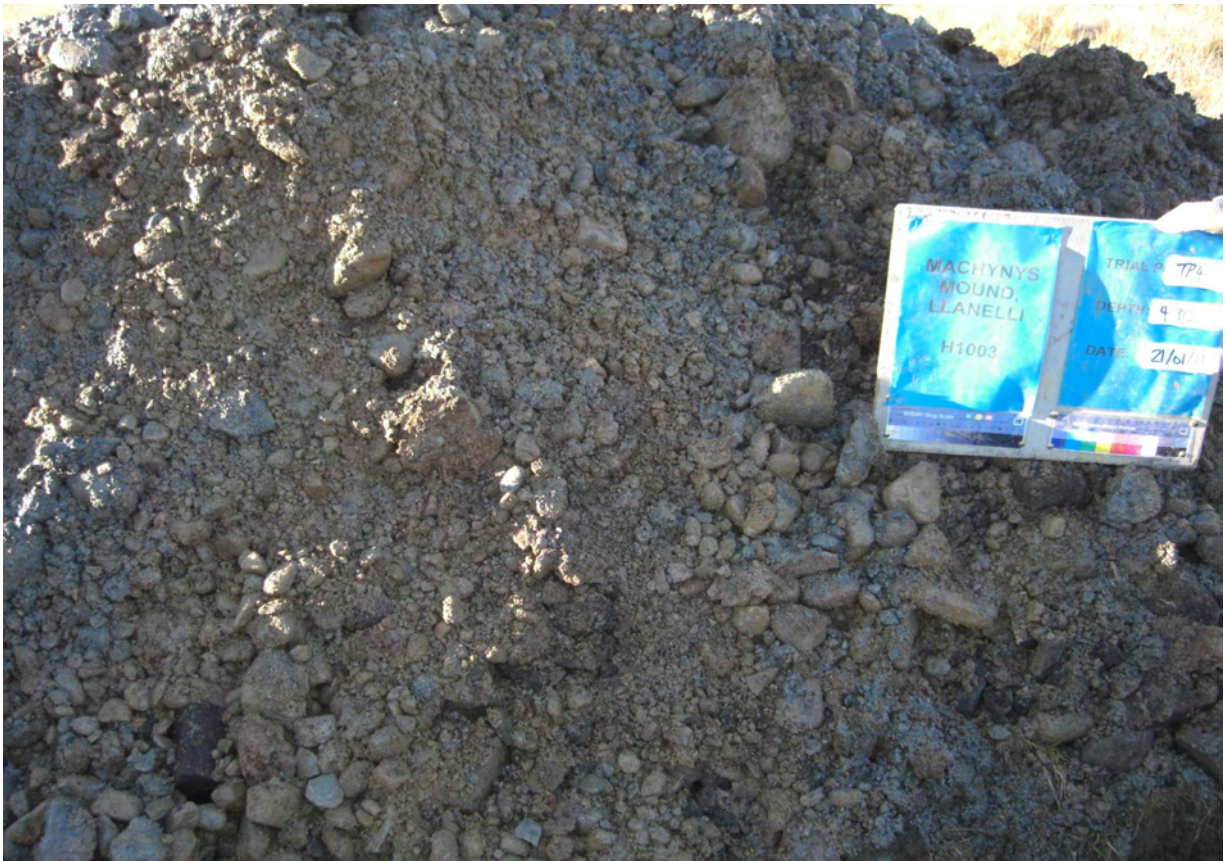
Trial Pit 4

Notes:	Project Machynys Mound, Machynys Project No. H1003-11 Carried out for Carmarthenshire County Council	Figure E8
--------	---	----------------------------

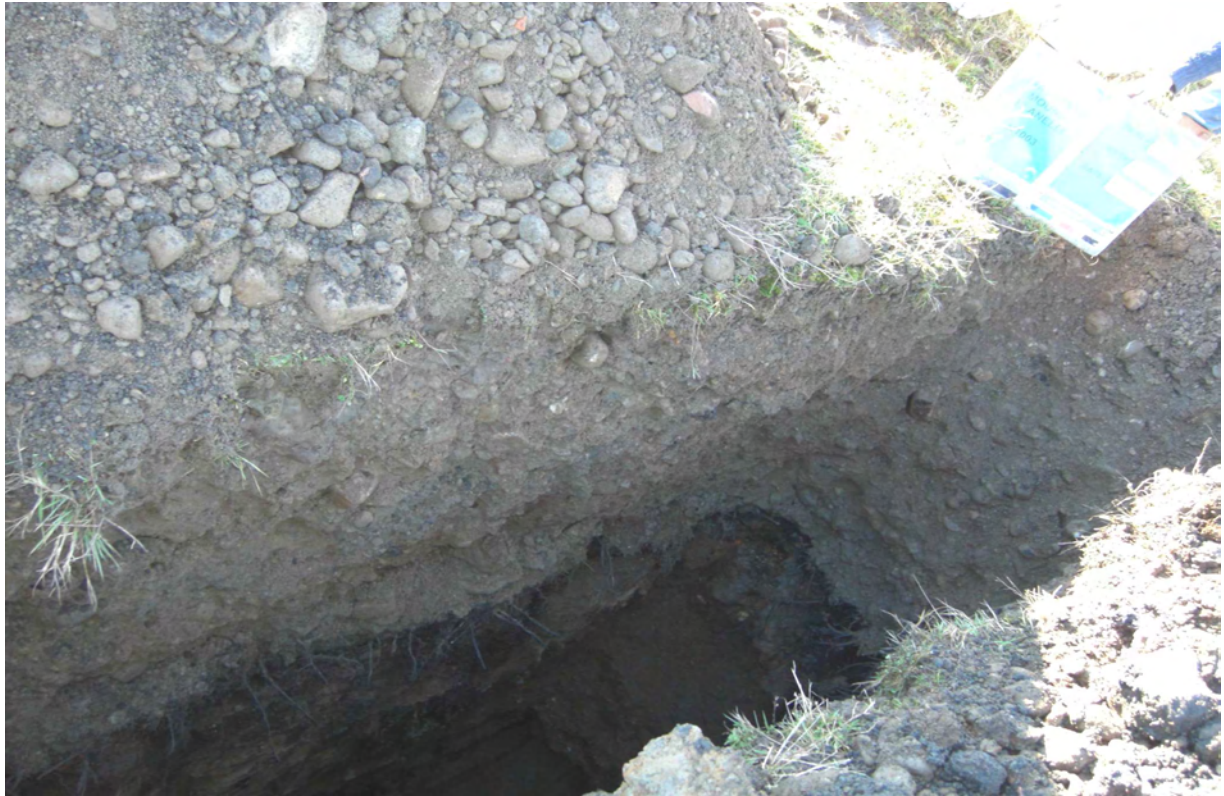
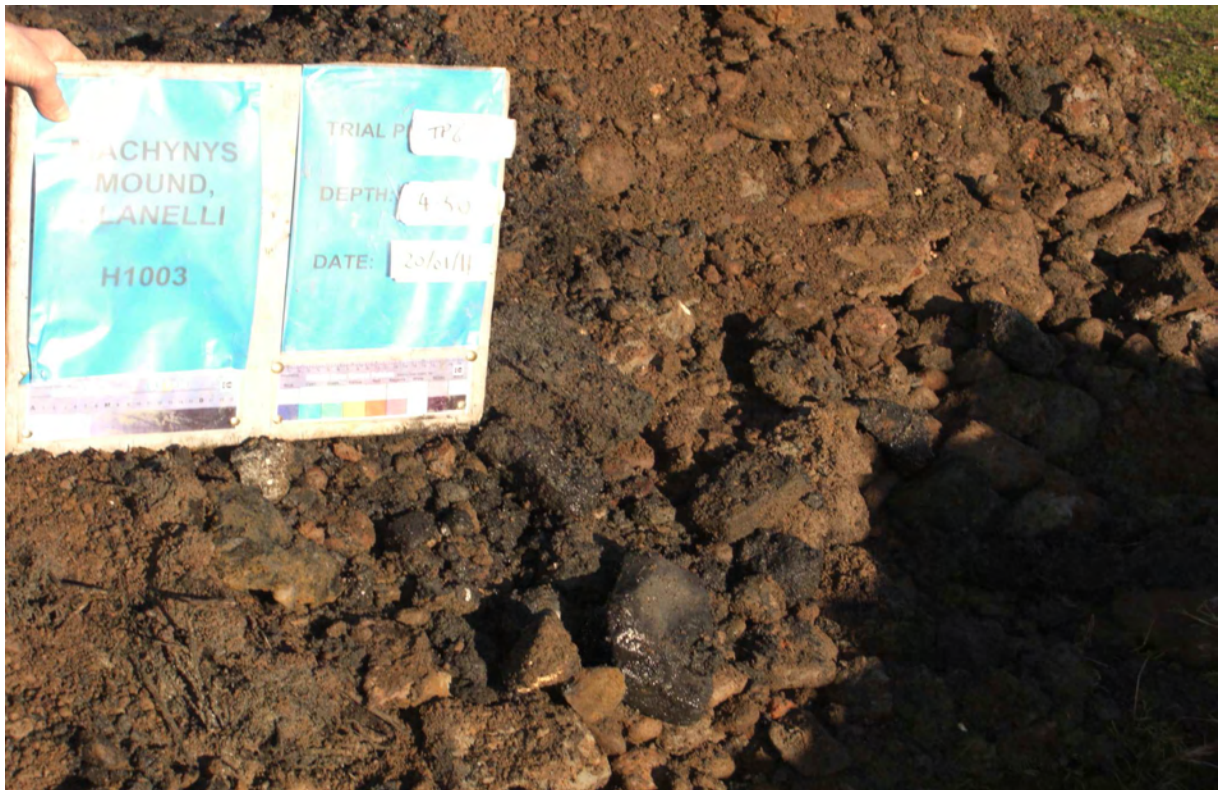
Trial Pit 6

Notes:	Project Machynys Mound, Machynys Project No. H1003-11 Carried out for Carmarthenshire County Council	Figure E12
--------	---	-----------------------------

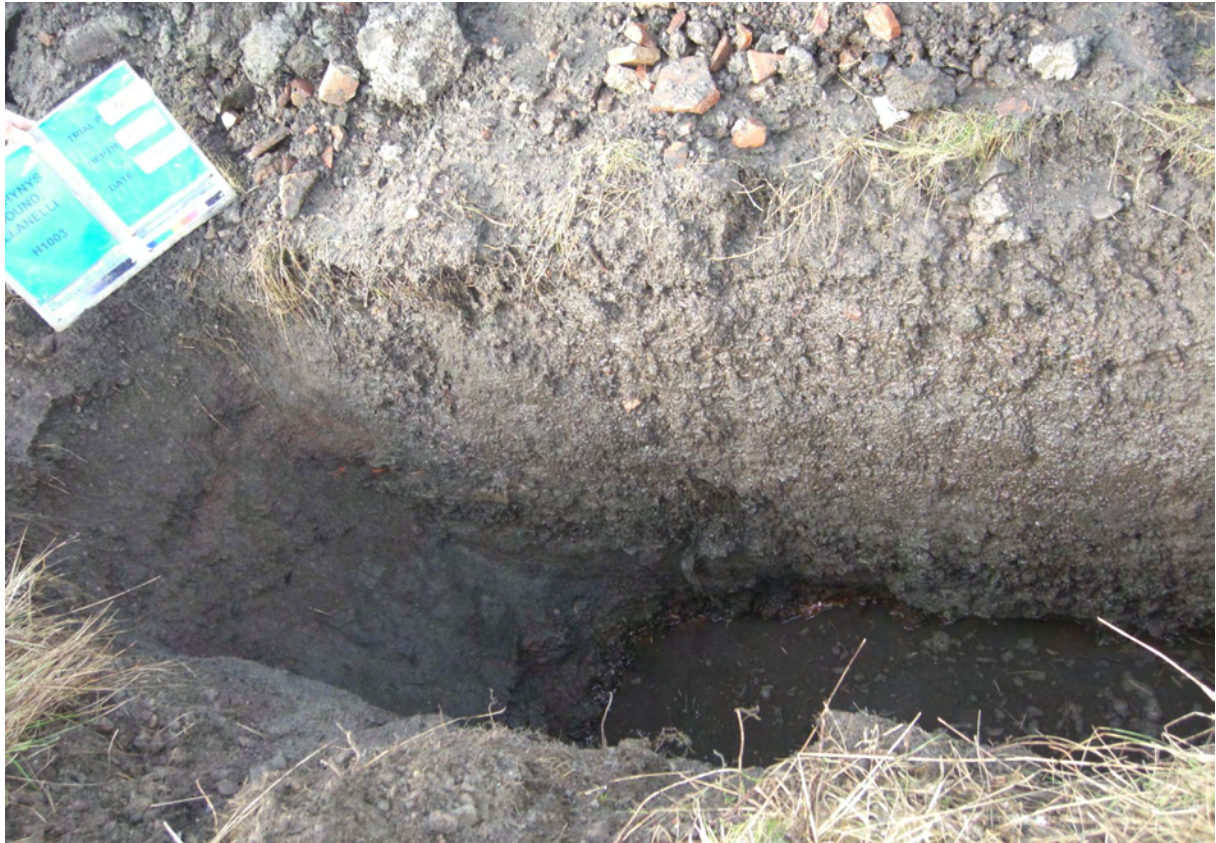
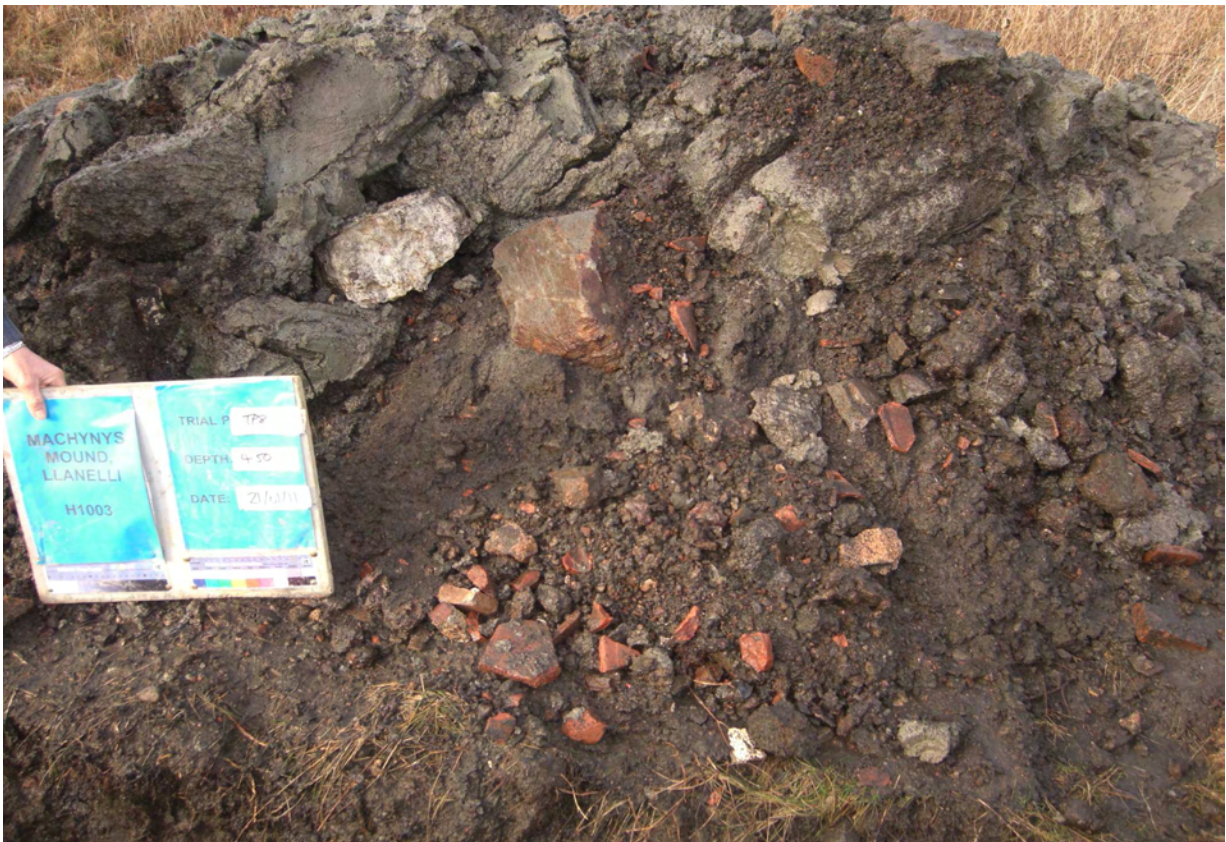
Trial Pit 8

Notes:	Project Machynys Mound, Machynys Project No. H1003-11 Carried out for Carmarthenshire County Council	Figure E16
--------	---	-----------------------------

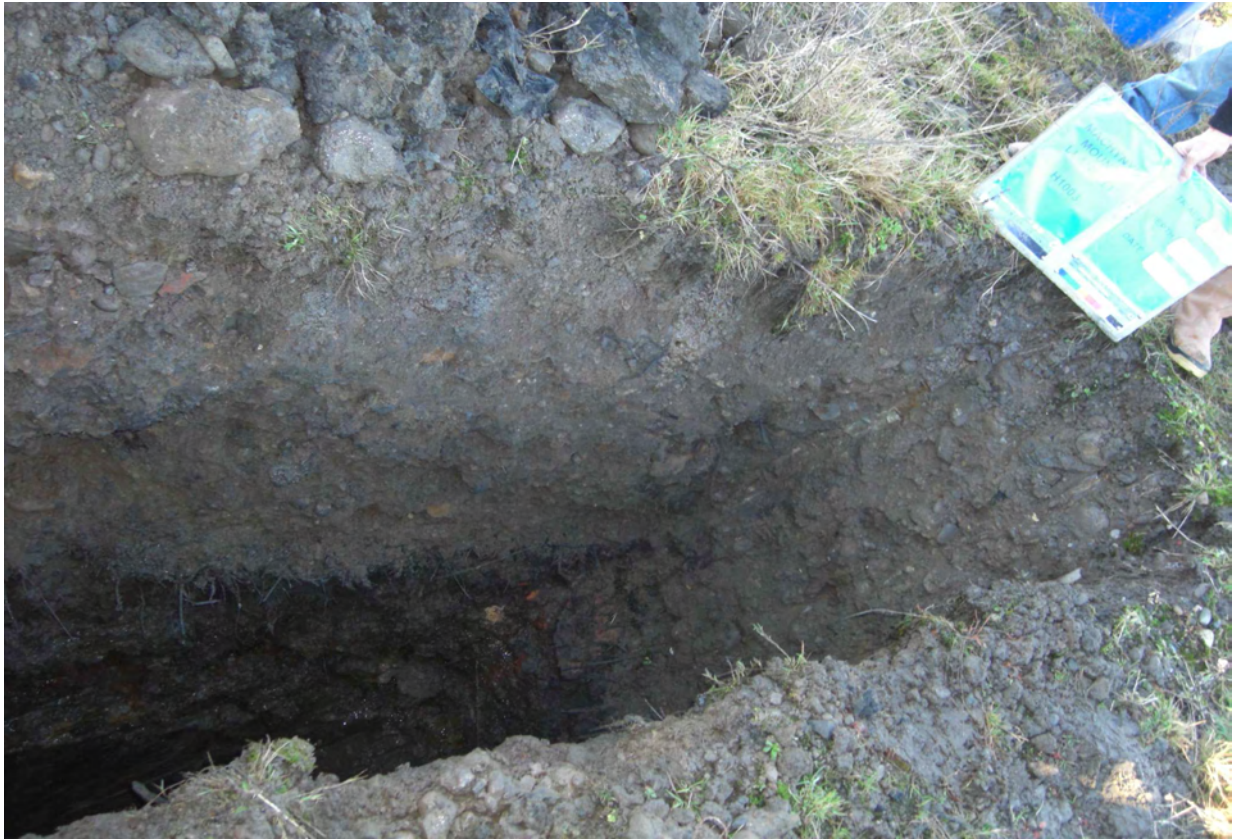
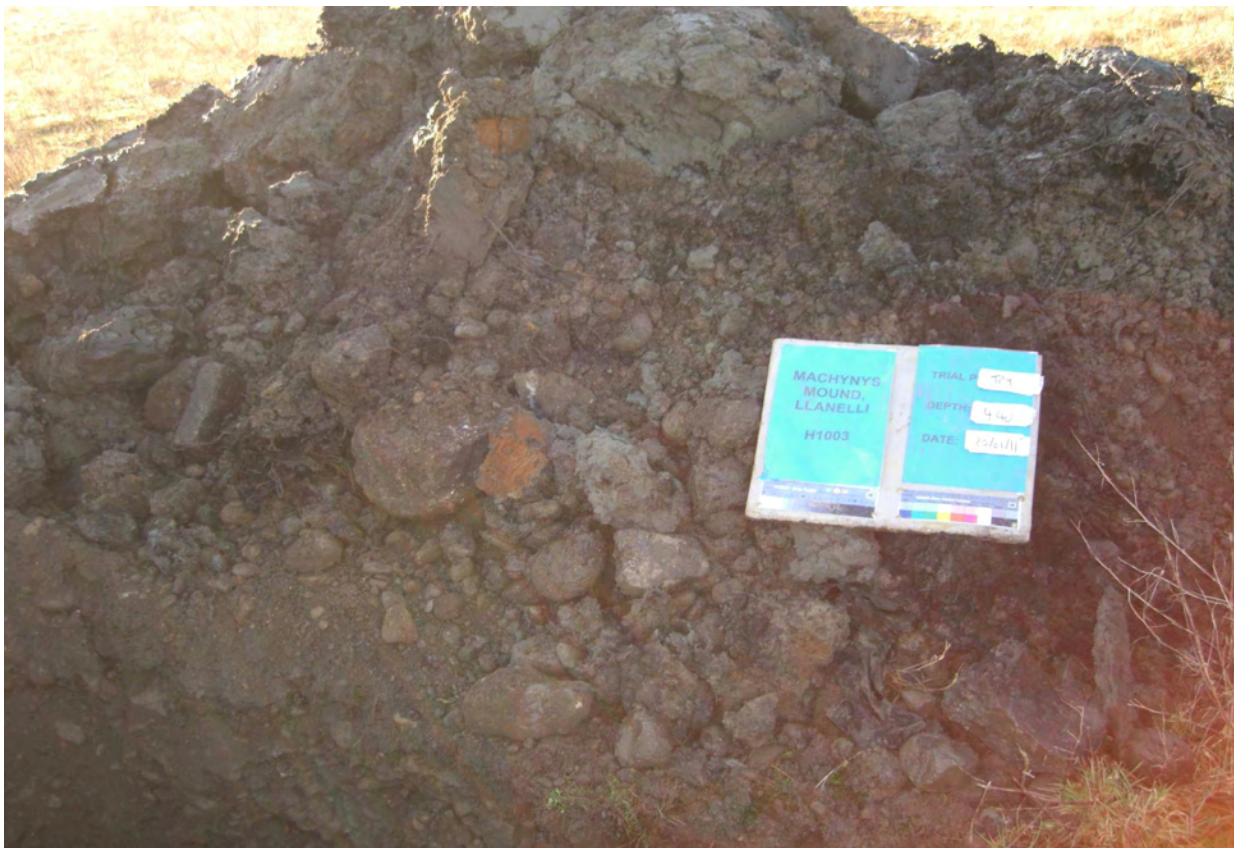
Trial Pit 9

Notes:	Project Machynys Mound, Machynys Project No. H1003-11 Carried out for Carmarthenshire County Council	Figure E18
--------	---	-----------------------------
